Subject: Submittal of the 2018 Monitoring Report for Los Alamos/Pueblo Watershed
Sediment Transport Mitigation Project

1. Two hard copies with electronic files – 2018 Monitoring Report for Los Alamos/Pueblo Watershed Sediment Transport Mitigation Project (EM2019-0106)

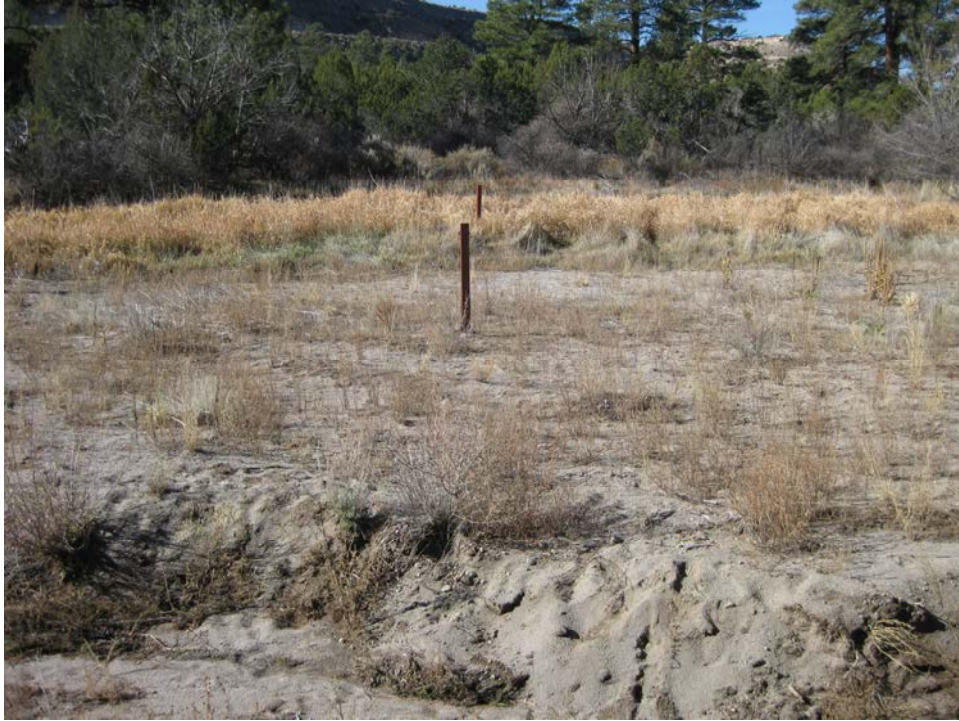
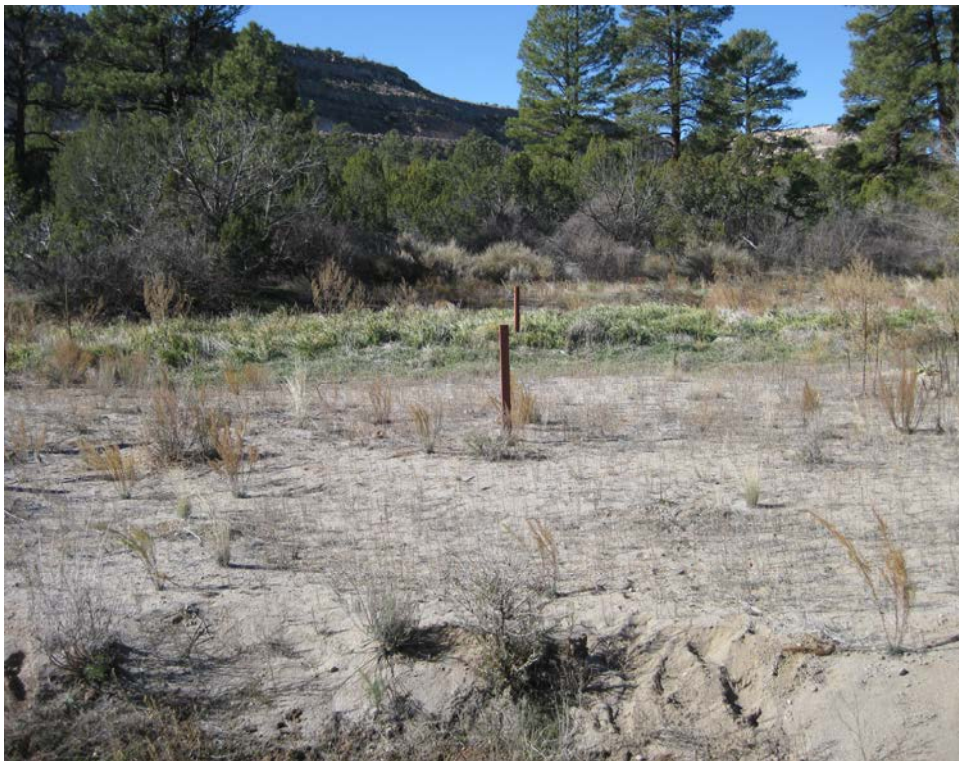
Photo A1-18 Willows planted in short-height, spatially-dispersed community (P-1) in 2014 in Pueblo Canyon lower willow-planting area, from northern stake at P4C+800, in (a) November 2016 and (b) in November 2018

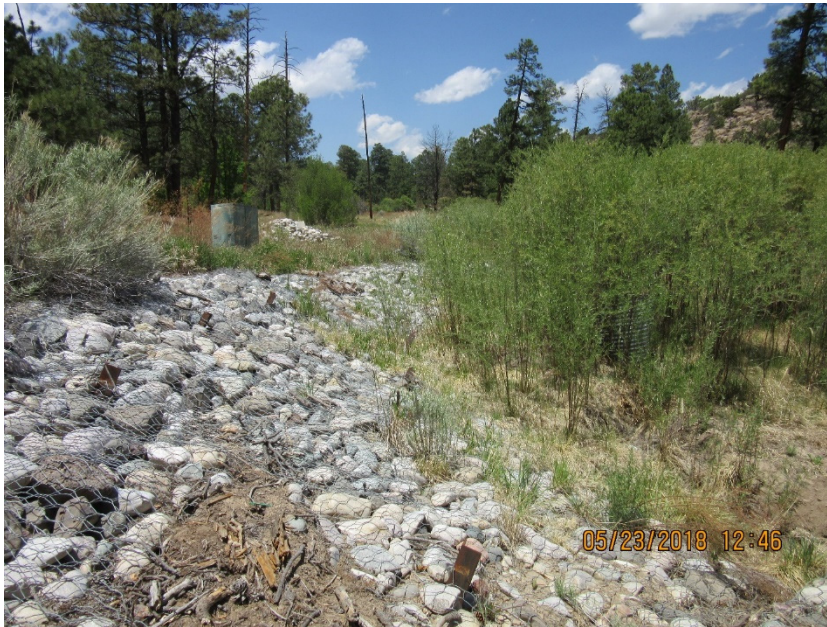
Photo B-2.1-1 May 2018—Embankment is stable and operating as designed. Well-established vegetation with no erosion occurring from hillslope. Some trash and debris present.

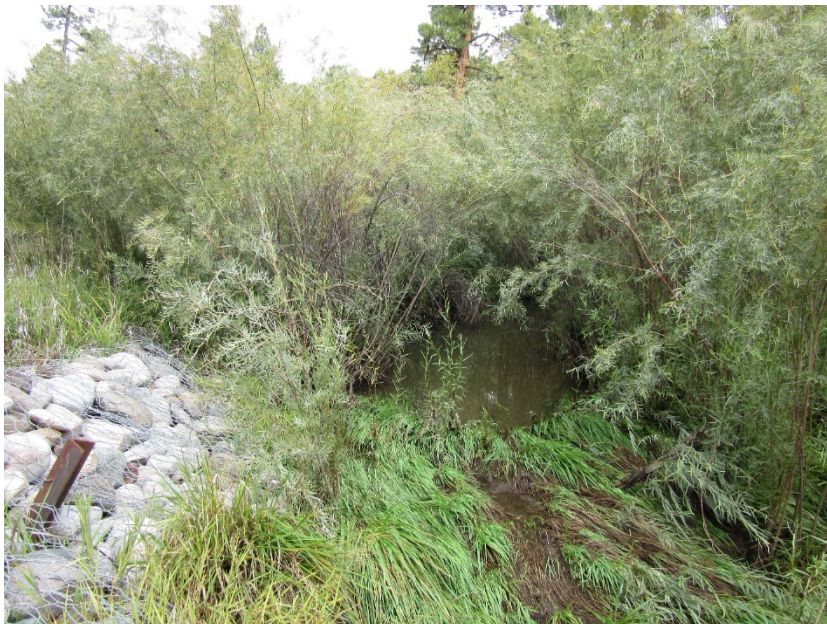
Photo B-2.1-2 Flow event inspection for September 4, 2018, storm event—Embankment is stable and operating as designed. Well-established vegetation with no erosion occurring from hillslope.

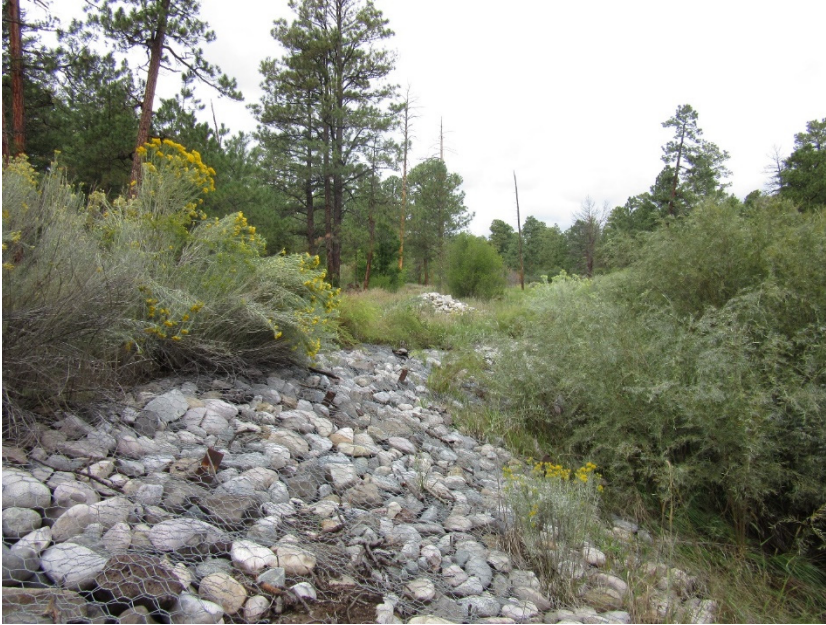
Photo B-2.1-3 Flow event inspection for September 4, 2018, storm event—Embankment is stable and operating as designed. Well-established vegetation with no erosion occurring from hillslope.

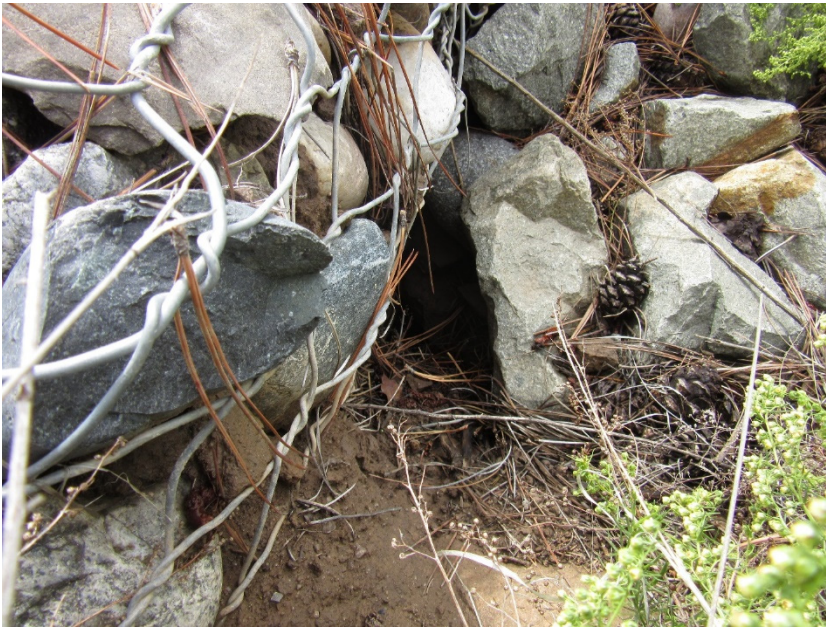
Photo B-2.1-4 Flow event inspection for September 4, 2018, storm event—Continue to monitor minor rodent-caused erosion on north-east corner of embankment.

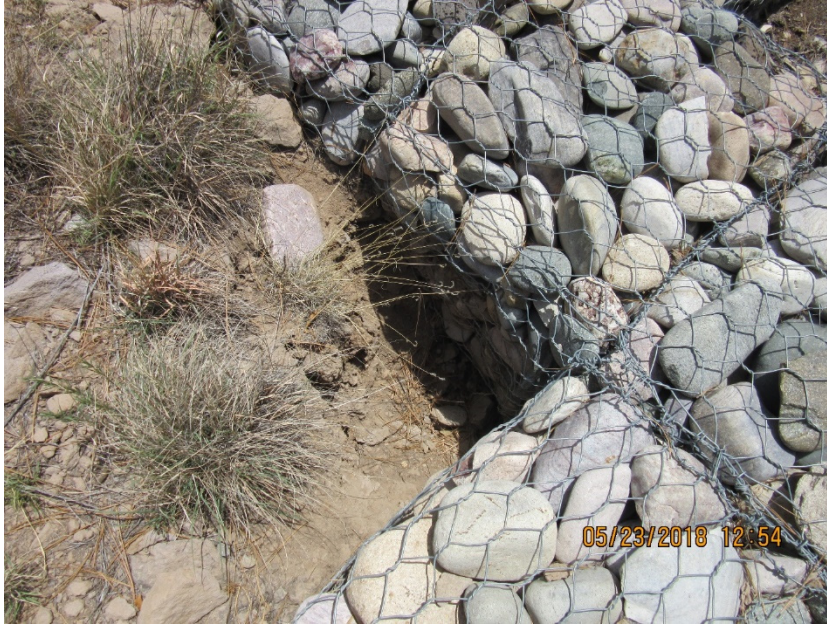
Photo B-2.1-5 May 2018—Erosion occurring at north-east corner of weir. No change since last inspection (October 2017), continue to monitor.

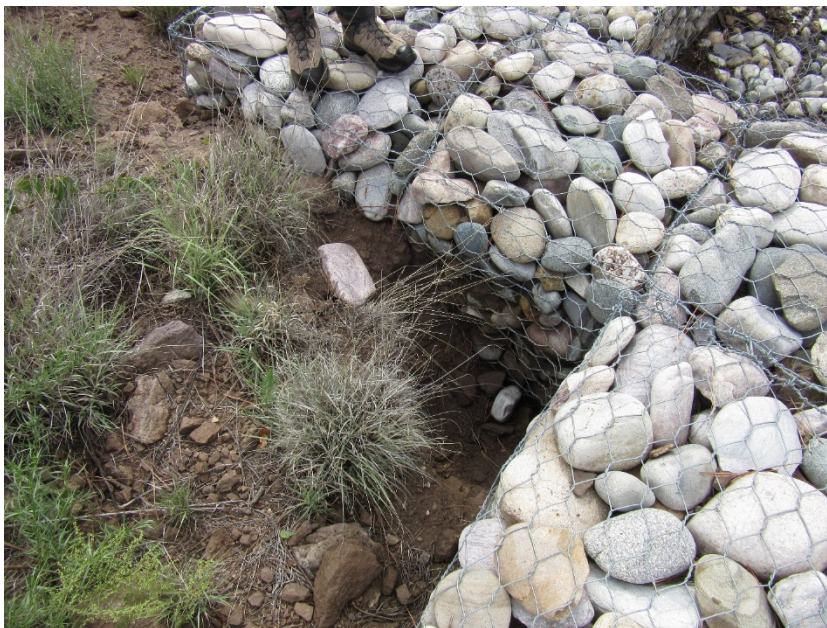
Photo B-2.1-6 Flow event inspection for September 4, 2018, storm event —Continue to monitor erosion occurring at north-east corner of weir. Not impacting structure. No change since last inspection (May 2018), continue to monitor.

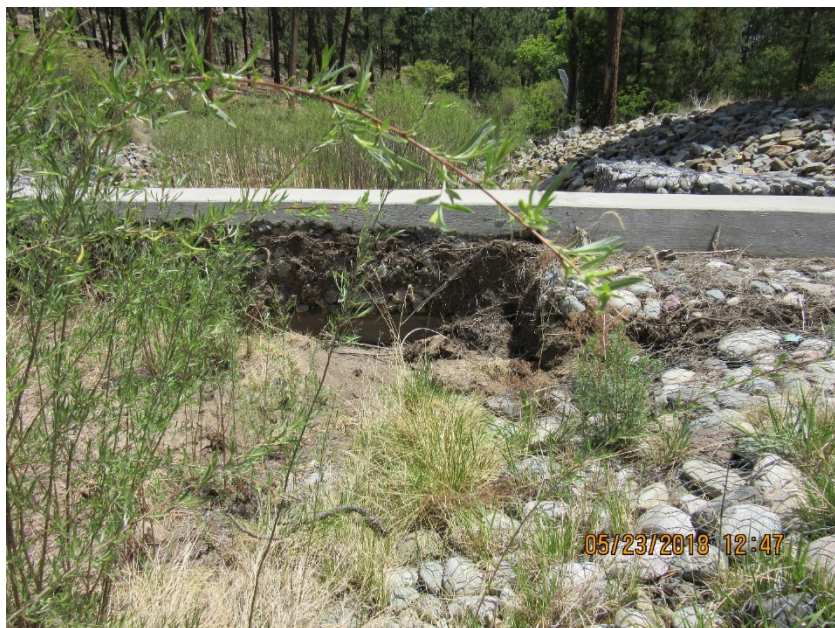
Photo B-2.2-1 May 2018—Upslope face of weir with some debris, looking east. Weir is functioning, no deteriorating joints or bulging gabion baskets. Continue to monitor crack on north end of weir. No change since last inspection.

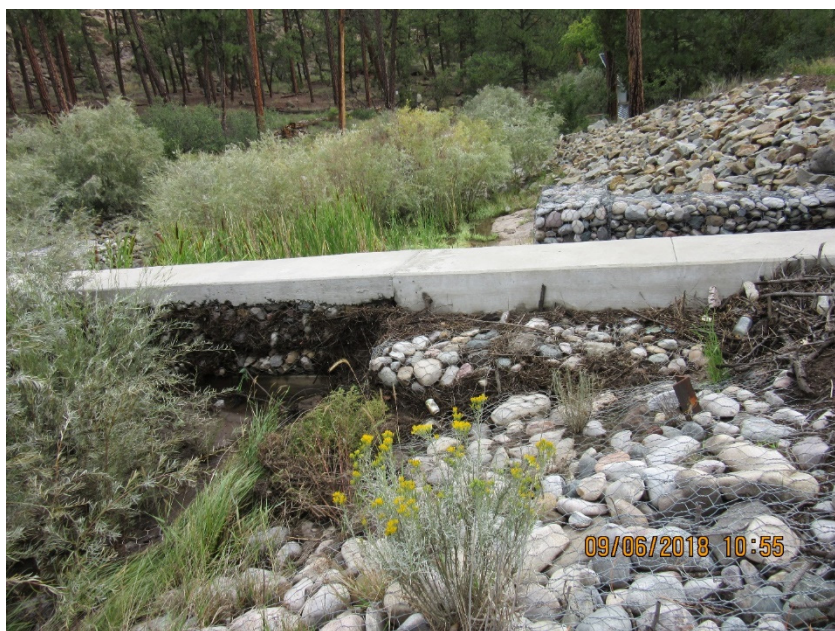
Photo B-2.2-2 Flow event inspection for September 4, 2018, rain event—Continue to monitor minor crack on north end of weir. No change since last inspection (May 2018). Some debris present because of flow event.

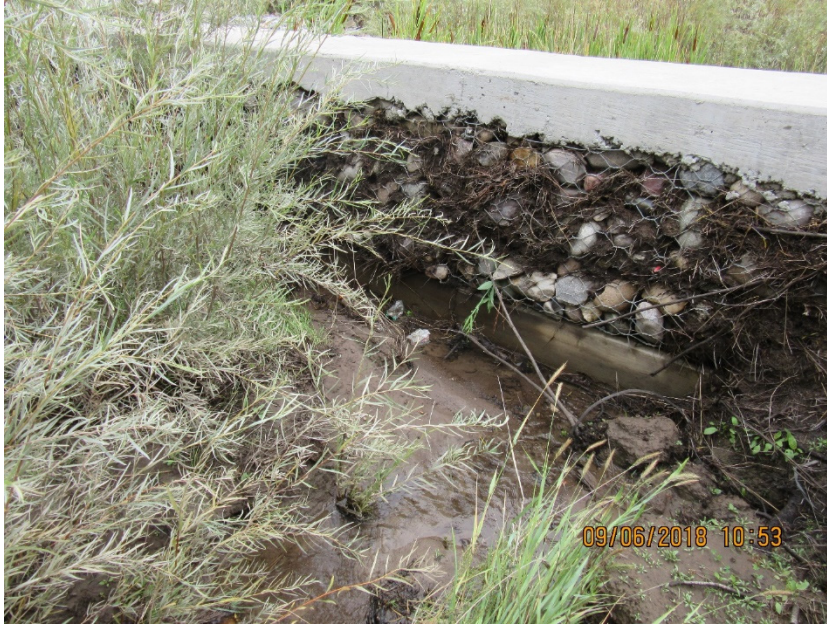
Photo B-2.2-3 Flow event inspection for September 4, 2018, rain event—Some debris present.

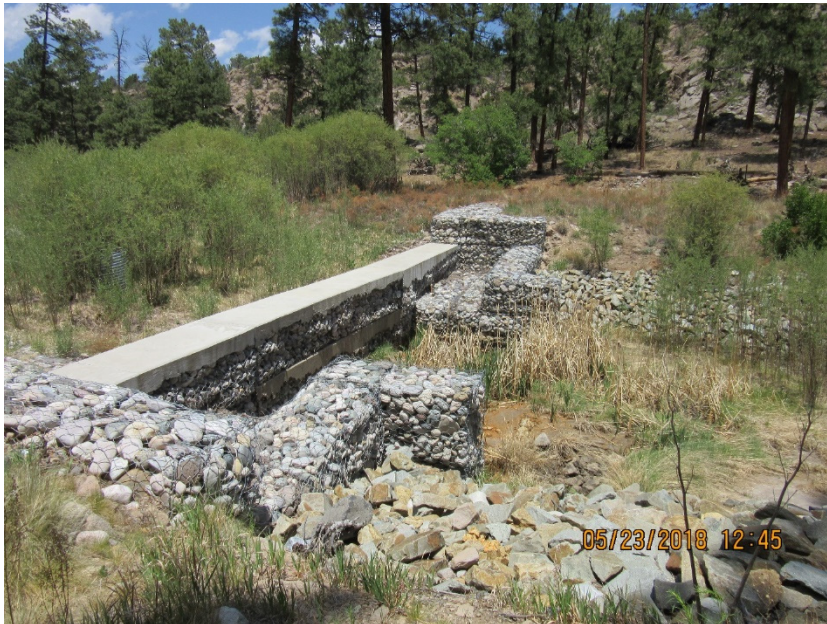
Photo B-2.3-1 May 2018—Weir structure looking upstream. No deteriorated joints present on upslope side of weir. Gabion basket is structurally intact and in stable condition. Continue to monitor for changes.

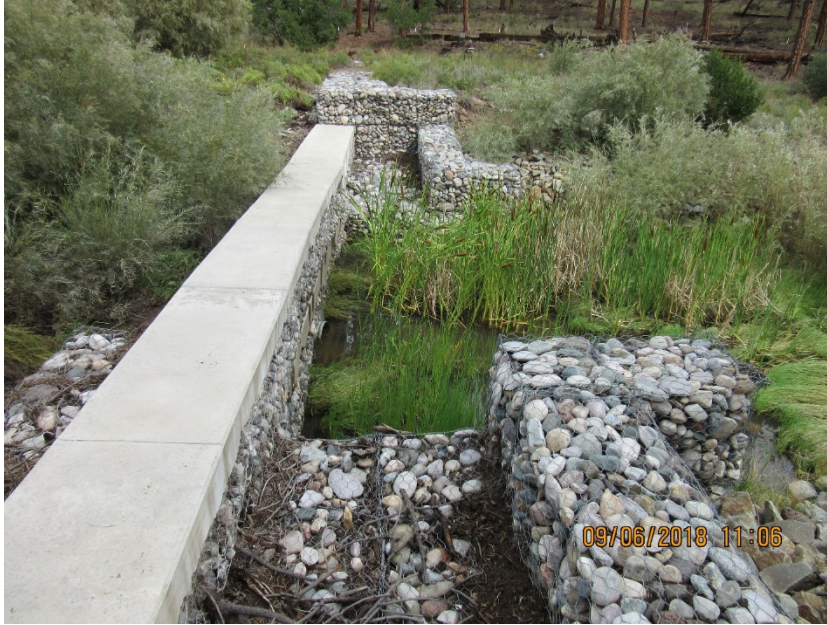
Photo B-2.3-2 Flow event inspection for September 4, 2018, storm event—Crest of weir structure. No deteriorated joints present on upslope side of weir. Gabion basket is structurally intact and in stable condition. Debris present. GCS outlet partially submerged with active flow.

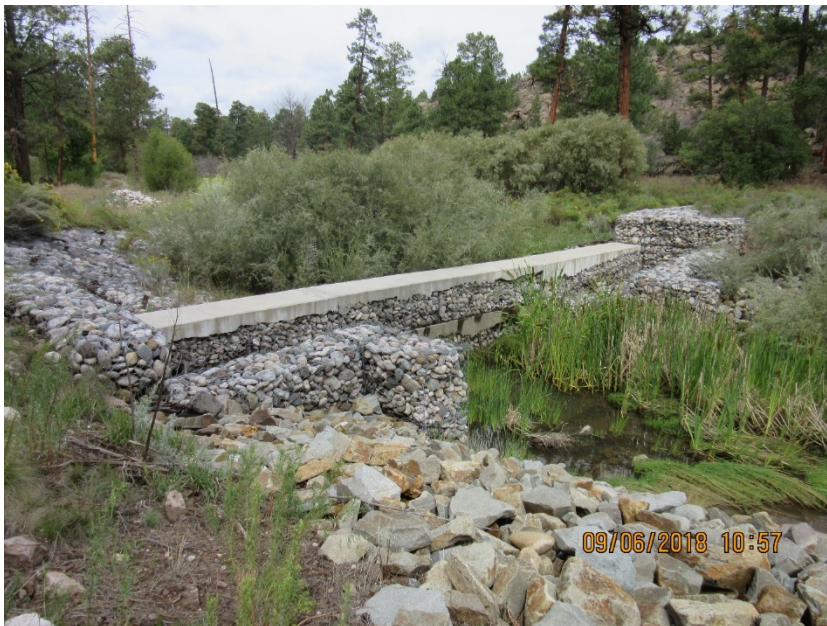
Photo B-2.3-3 Flow event inspection for September 4, 2018, storm event—Weir structure looking upstream. No deteriorated joints present on upslope side of weir. Gabion basket is structurally intact and in stable condition.

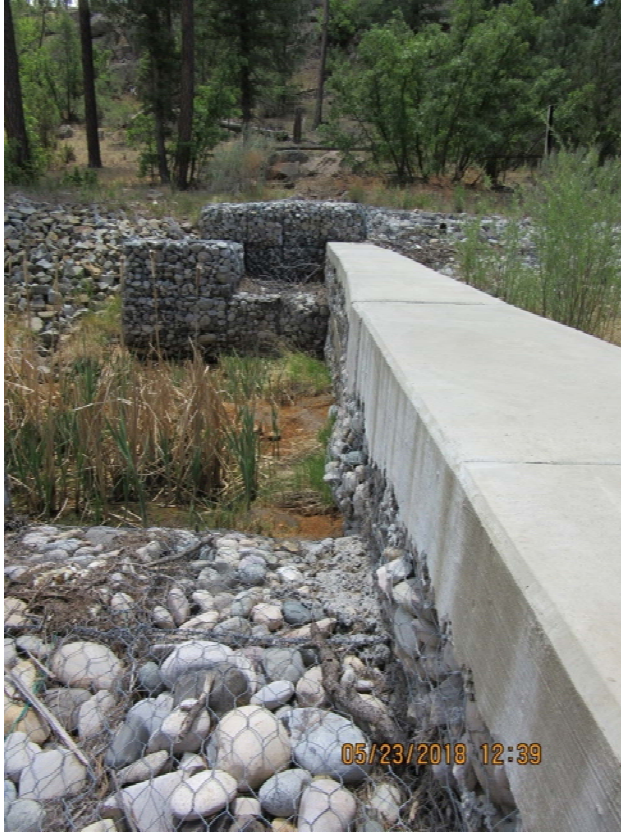
Photo B-2.4-1 May 2018—Downstream face of weir. Continue to monitor bulging gabion baskets and rusting gabion basket. No evidence of cracking/spalling, area is clear of debris.

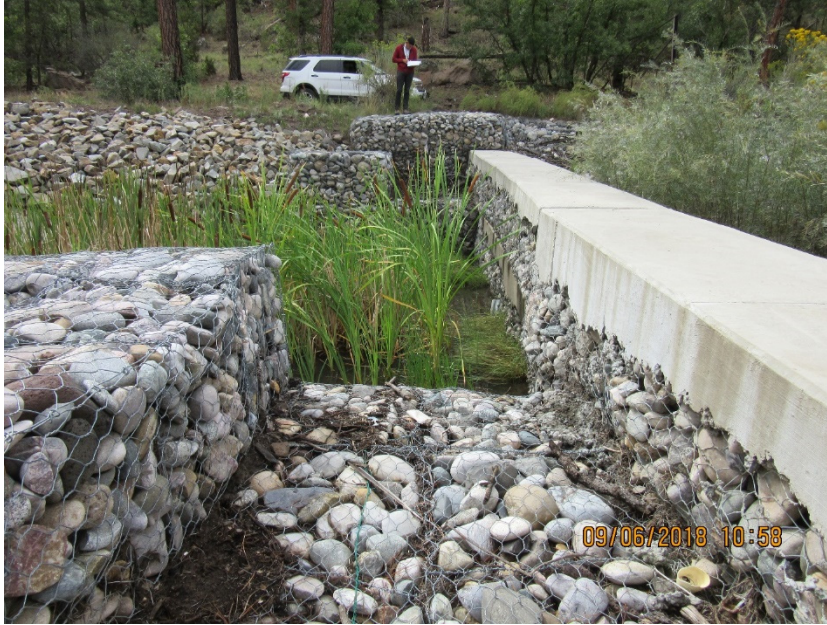
Photo B-2.4-2 Flow event inspection for September 4, 2018, rain event—Downstream face of Weir. Continue to monitor bulging gabion basket and rusting gabion baskets. No change since last inspection (May 2018).

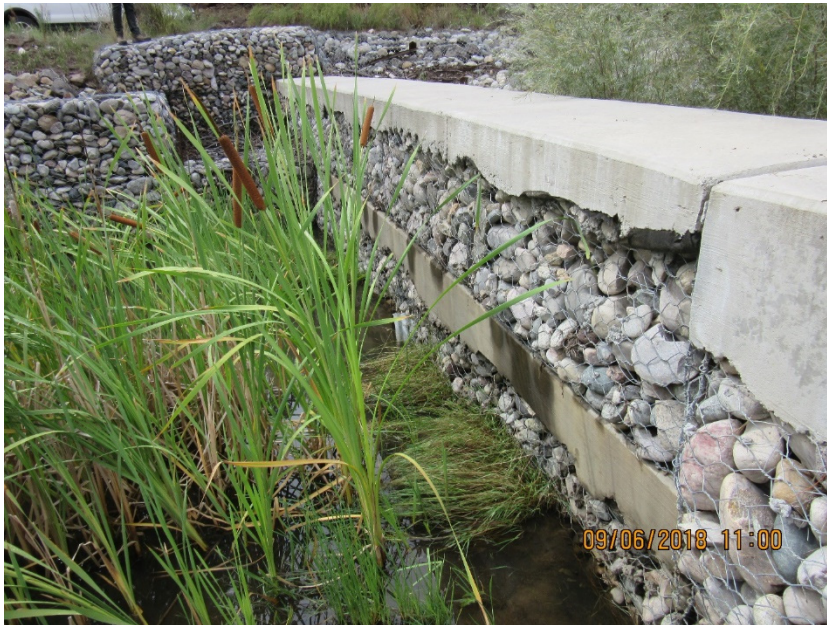
Photo B-2.4-3 Flow event Inspection for September 4, 2018, rain event—Downstream face of Weir. Water was actively flowing within channel. Water upstream of structure was seeping into standpipe. Water seeping through gabions. Wetness visible on concrete.

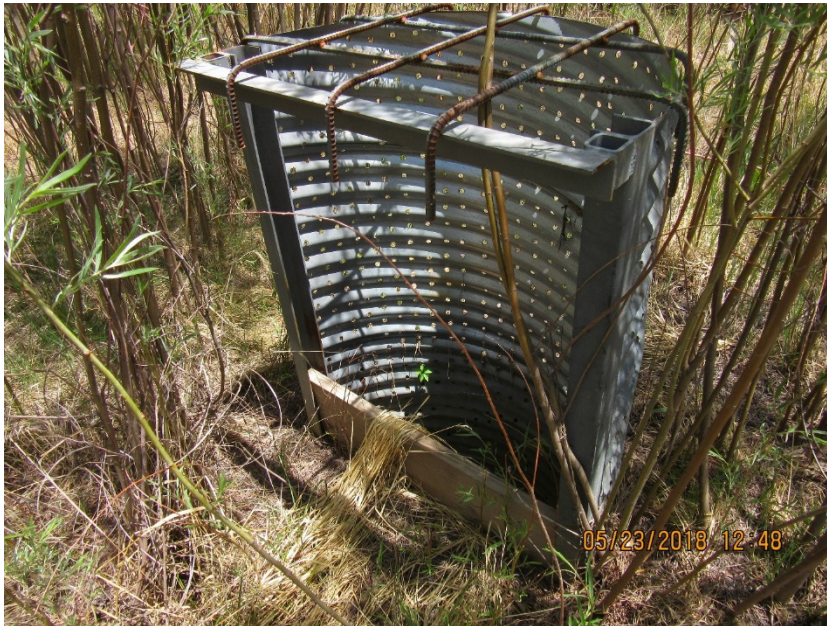
Photo B-2.5-1 May 2018—Standpipe. Standpipe has approximately 6 9n. of freeboard to top of standpipe level control board. Tire is present within standpipe. Standpipe is functional. Continue to monitor corrosion.

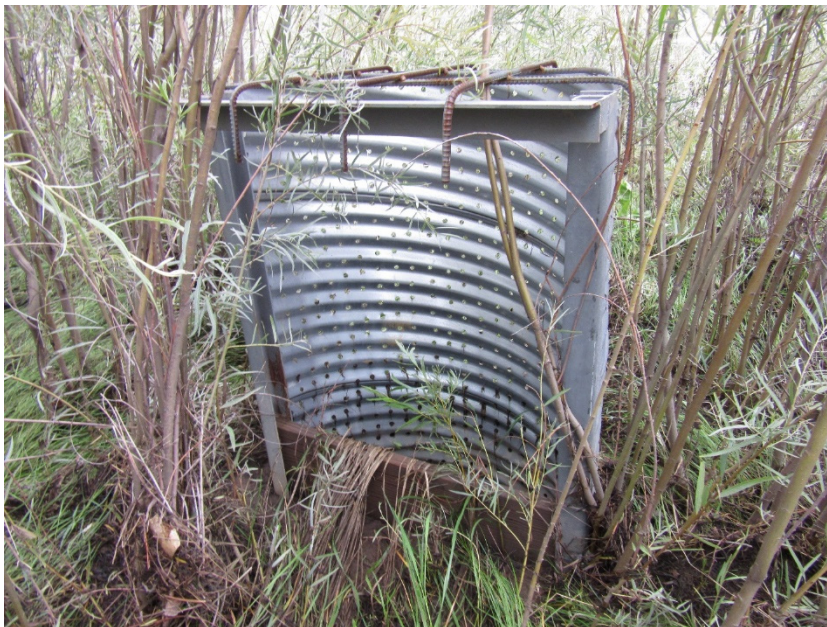
Photo B-2.5-2 Flow event inspection for September 4, 2018, rain event—Standpipe with approximately 6–8 in. of freeboard to top of standpipe level control board. Tire is present within standpipe. Standpipe is functional. Continue to monitor corrosion.

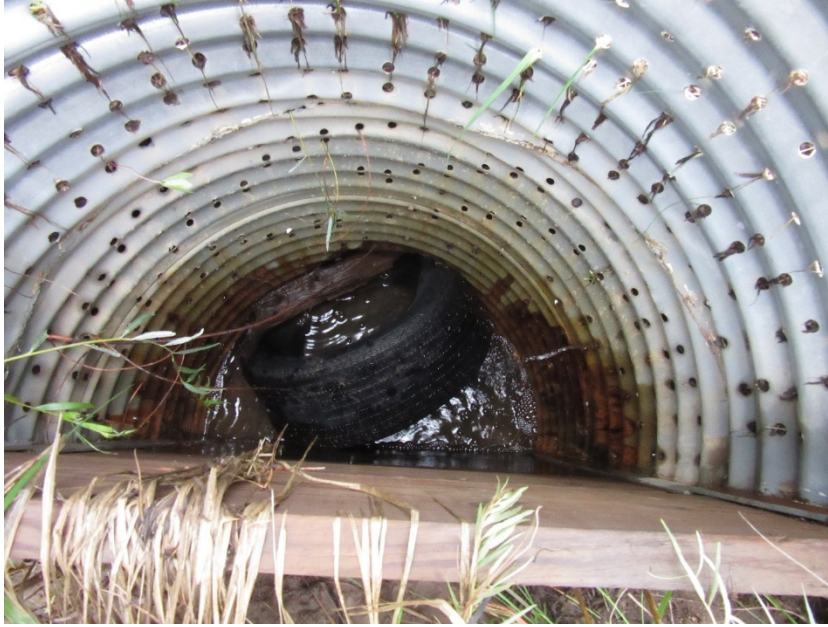
Photo B-2.5-3 Flow event inspection for September 4, 2018, rain event—Tire is present within standpipe. Standpipe is functional. Continue to monitor corrosion.

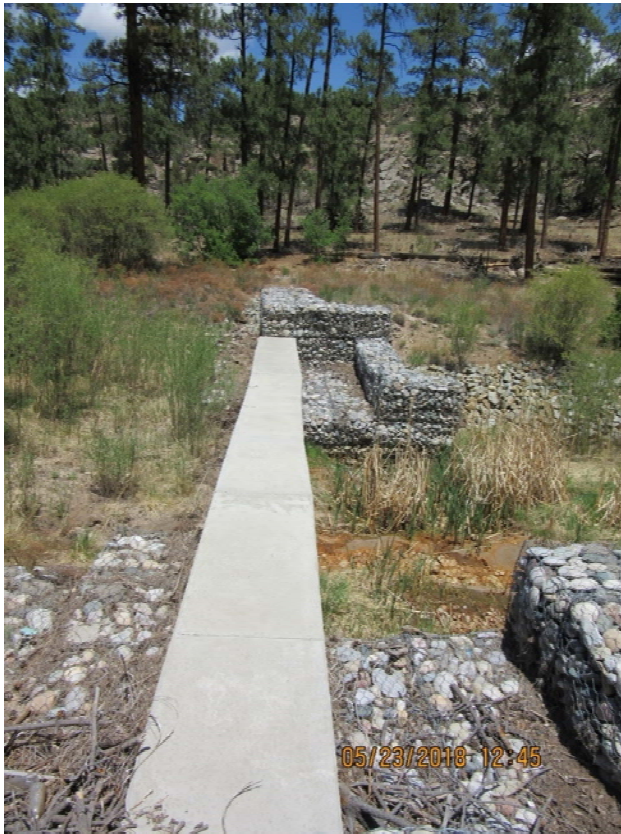
Photo B-2.6-1 May 2018—Spillway alignment. Spillway operating as designed. No sign of improper alignment, deterioration, or trash/debris on spillway.

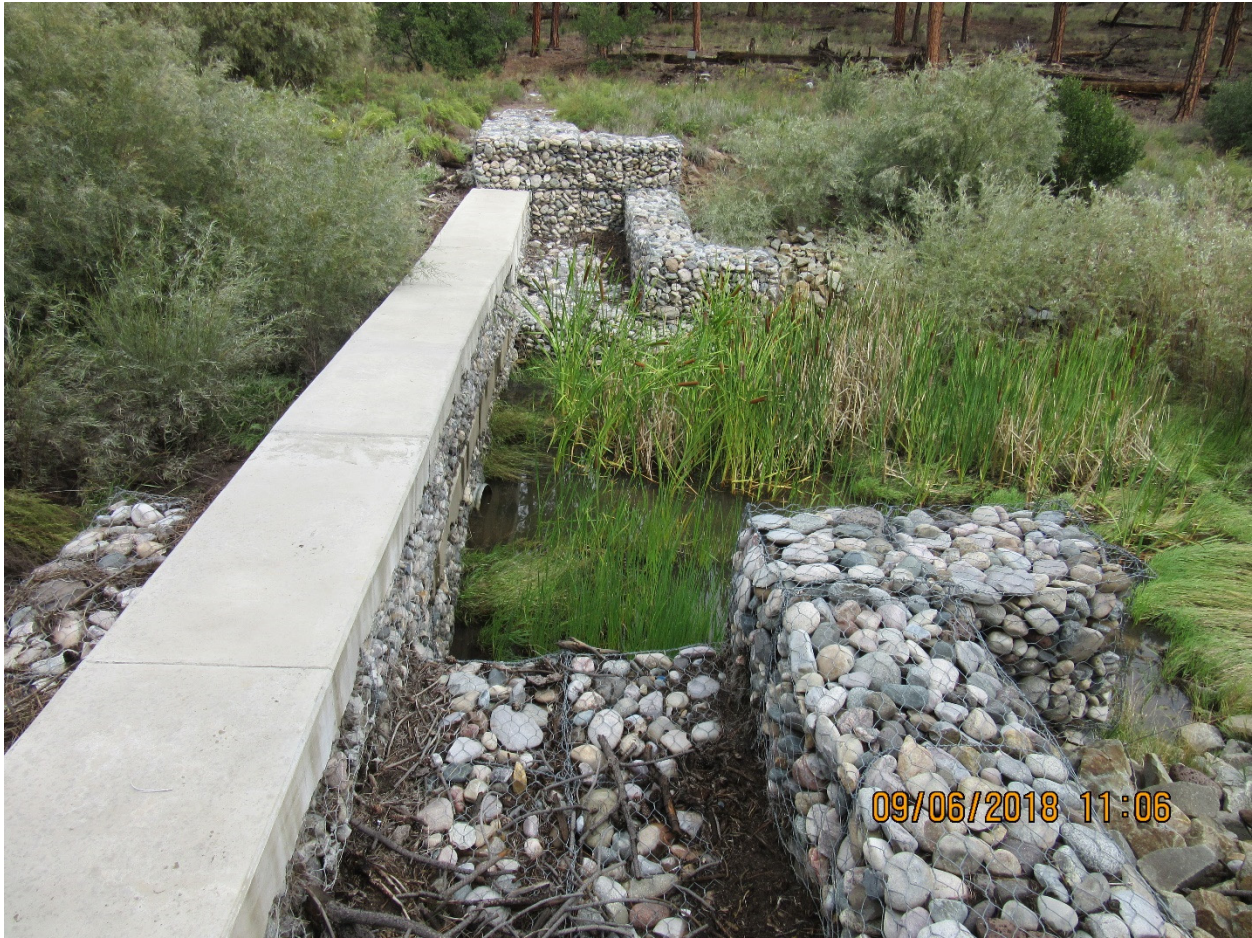
Photo B-2.6-2 Flow event inspection for September 4, 2018, rain event. No signs of improper alignment, deterioration, or trash/debris on spillway.

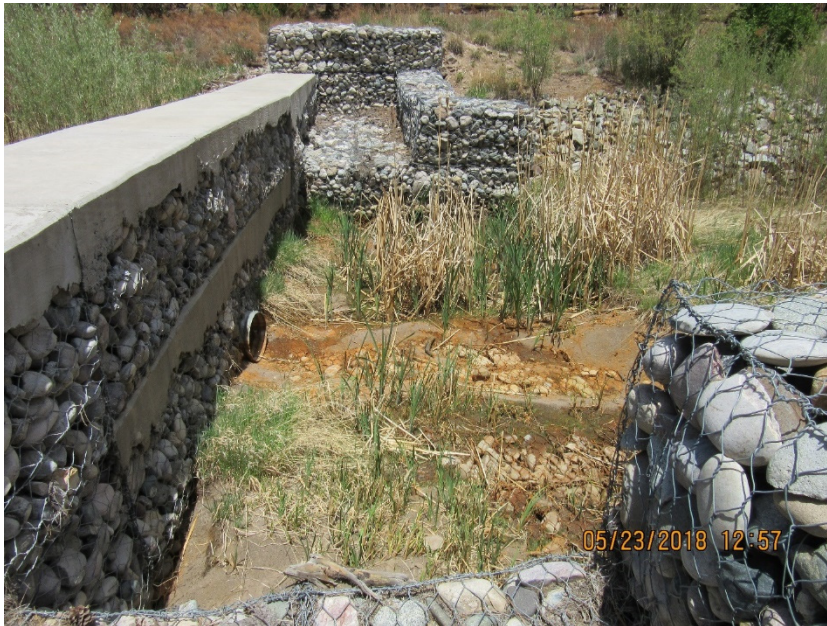
Photo B-2.7-1 May 2018—Outlet corrosion. Outlet pond was dry at time of inspection. No evidence of undercutting, erosion, or excessive sediment deposition at time of inspection.

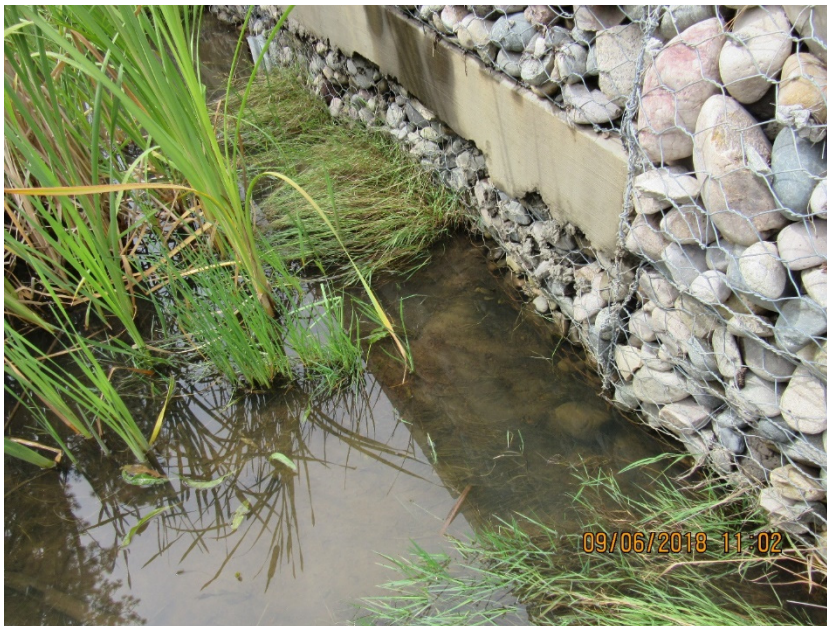
Photo B-2.7-2 Flow event inspection for September 4, 2018, rain event—Outlet submerged because of active flow. No erosion concerns noted. No significant amount of new sediment deposition with latest flow event. Outlet is also pictured on photos 2.3-2, 2.3-3, 2.4-3, and 2.6-2.

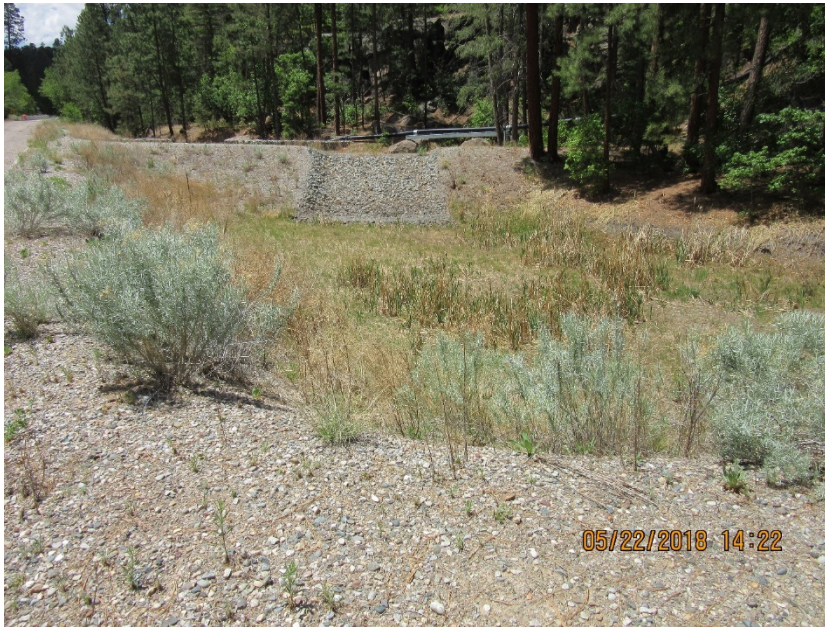
Photo B-3.1-1 May 2018—Lower basin. No breaching/slides/cracks/sloughs present on embankment and pond. No erosion occurring on slope. Pond is dry. No trash or debris present in control. Continue to monitor rodent burrows.

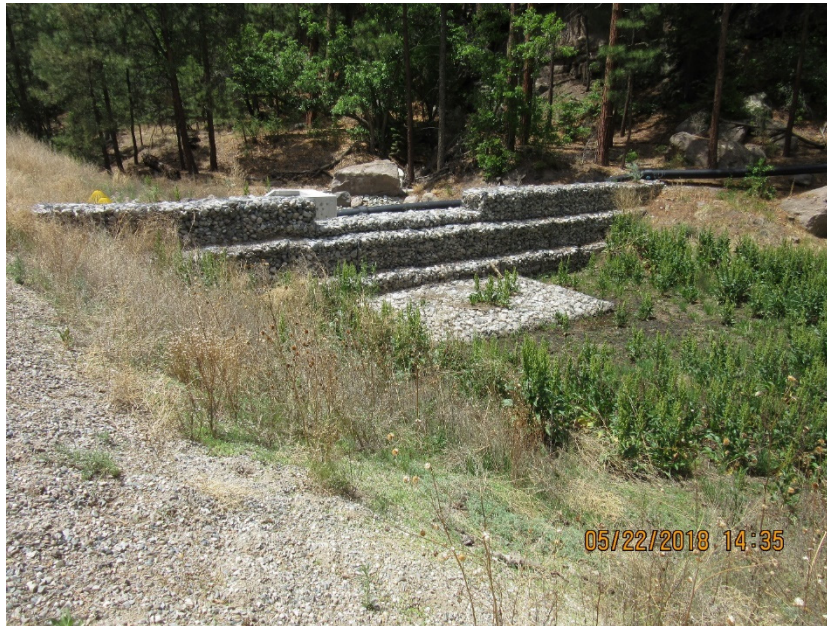
Photo B-3.2-1 May 2018—Upper basin. No breaching/slides/cracks/sloughs present on embankment and pond. No erosion occurring on slope. Pond is wet, no standing water. No trash or debris present in control. Continue to monitor rodent burrows.

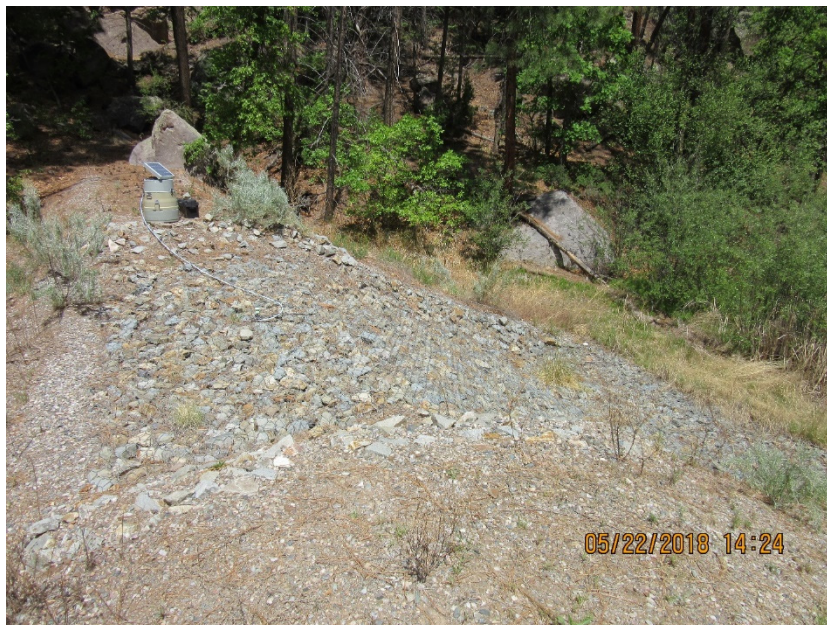
Photo B-3.3-1 May 2018—Lower basin spillway. No signs of erosion occurring on or near spillway. Spillway is maintaining alignment and stability. Continue to monitor rodent burrows.

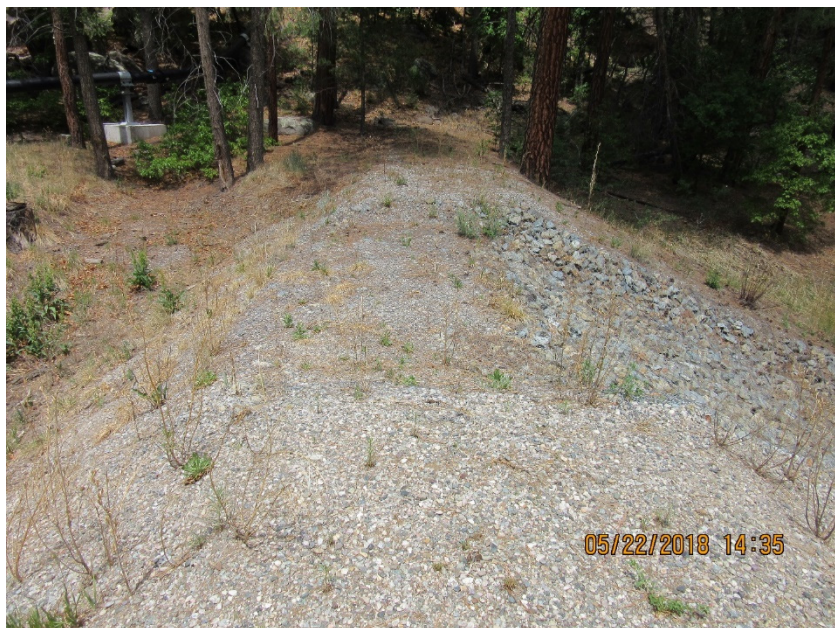
B-3.4 Upper Basin Spillway

Photo B-3.4-1 May 2018—Upper basin spillway. No signs of erosion occurring on or near spillway. Spillway is maintaining alignment and stability. Continue to monitor rodent burrows.

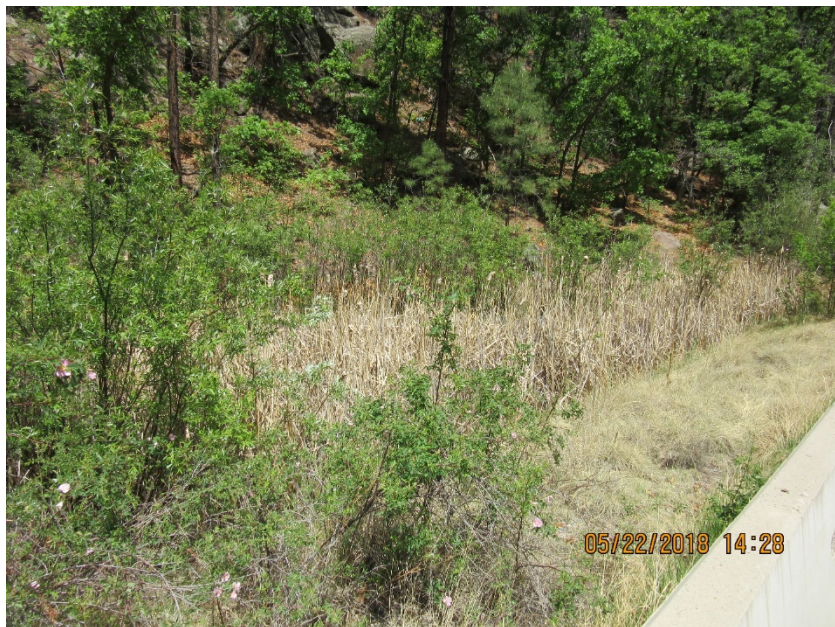
B-3.5 Wetland and Culvert

Photo B-3.5-1 May 2018—Wetland vegetation. Willows and wetland vegetation well established, stable, and clear of trash/debris. No seepage or piping occurring.

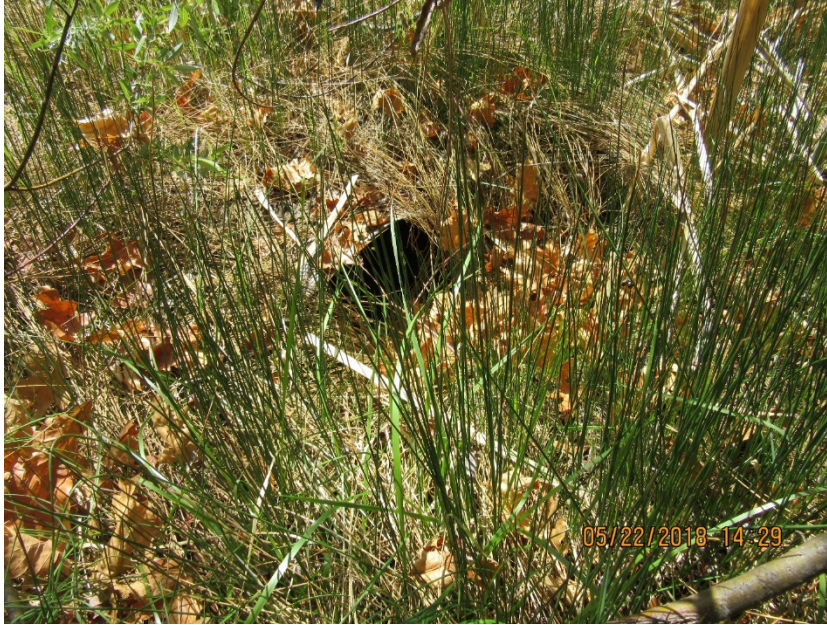
Photo B-3.5-2 May 2018—Culvert inlet is two-thirds blocked, this is consistent with previous inspection (October 2017). Willows and wetland vegetation well established, stable, and clear of trash/debris. No seepage or piping occurring.

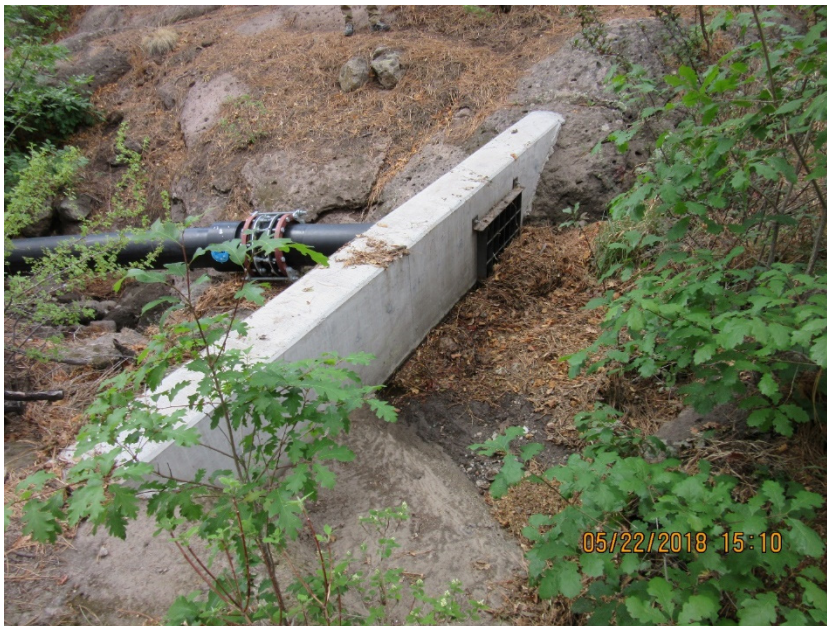
B-3.6 Upstream Pipeline and Appurtenances

Photo B-3.6-1 May 2018—Pipeline headwall displaying significant needle cast debris. Headwall functioning as designed. Needle cast is blocking portion of pipe inlet grate.

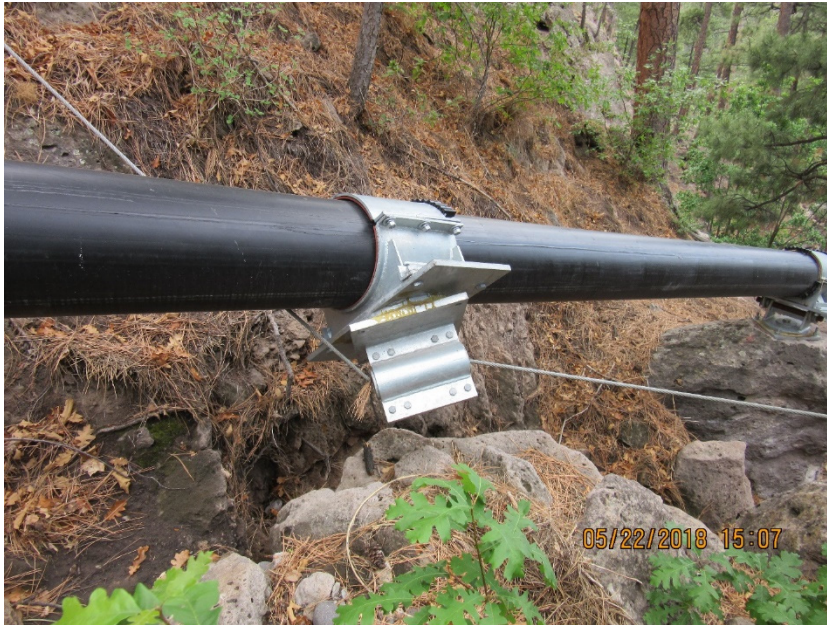
Photo B-3.6-2 May 2018—Pipeline cable support is skewed

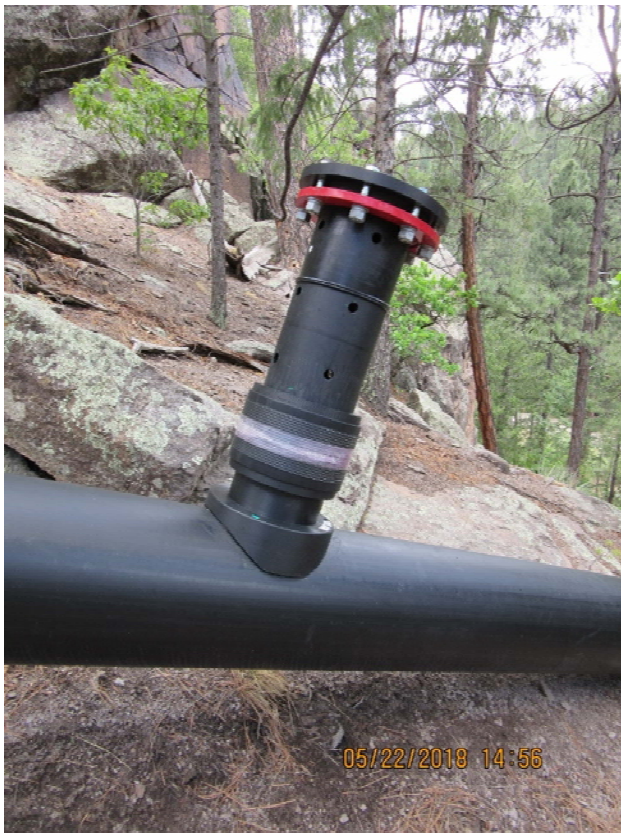
B-3.7 Upstream Pipeline Vacuum Breaker

Photo B-3.7-1 May 2018—Pipeline vacuum breaker. Control is operating as designed with no apparent issues to structure.

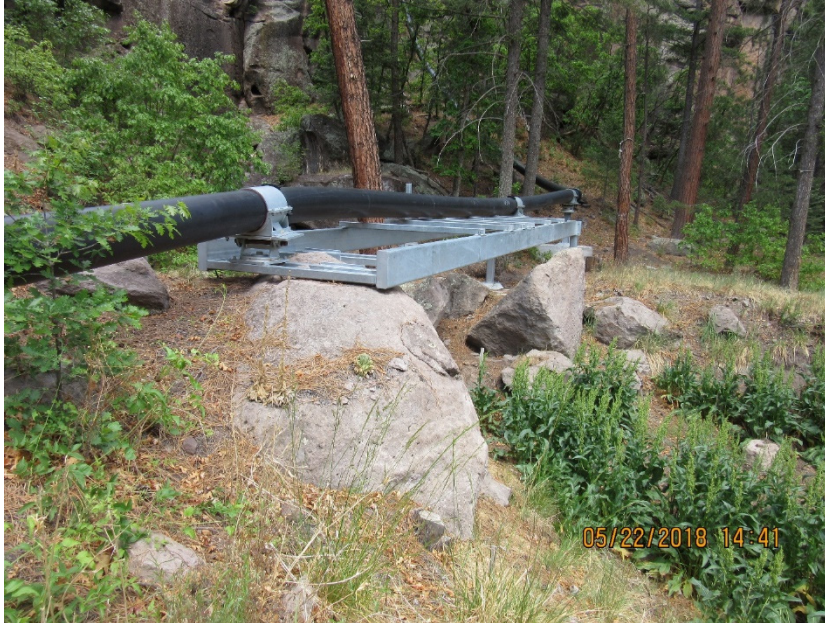
B-3.8 Upstream Pipeline Bridge Structure

Photo B-3.8-1 May 2018—Pipeline bridge structure. Control is operating as designed with no apparent issues to structure.

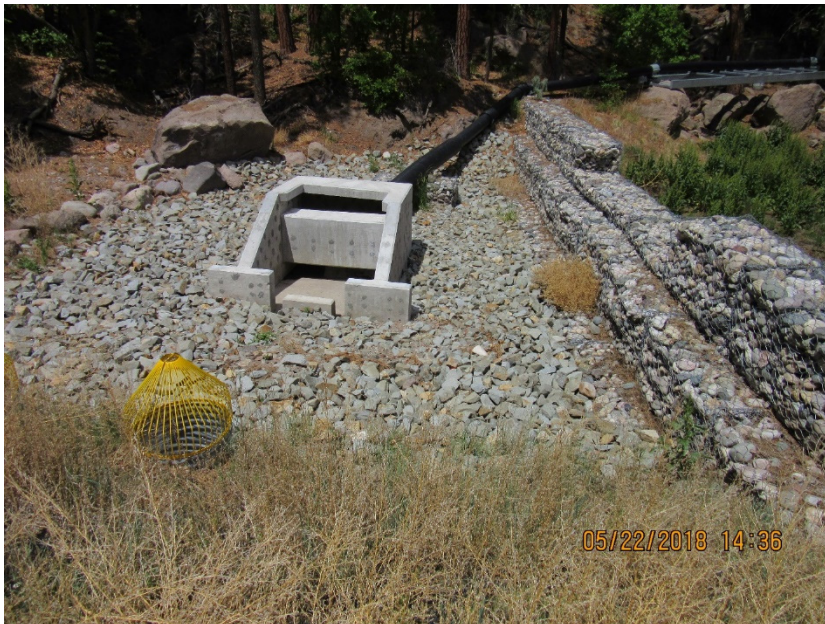
B-3.9 Pipeline Outlet and Energy Dissipater

Photo B-3.9-1 May 2018—Pipeline outlet, energy dissipater, and gabion overflow structure. Pipeline outlet and energy dissipater is clear of debris with minor established vegetation occurring through turf-reinforcement mat (TRM). Culvert outlet and inlets appear functional.

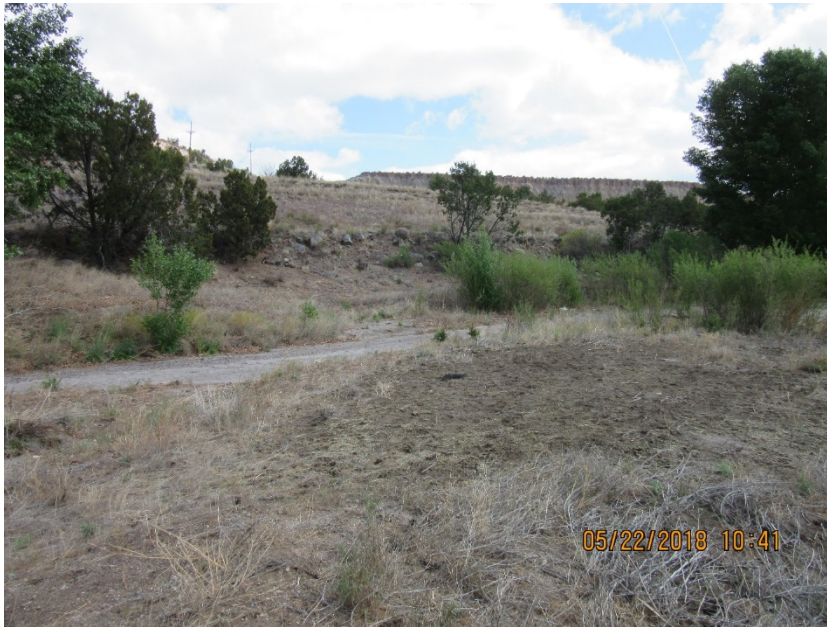
B-4.1 Weir Upstream Slope Embankment

Photo B-4.1-1 May 2018—Upstream northern embankment slope. Slope embankment is stable with established vegetation. Continue to monitor rodent burrows.

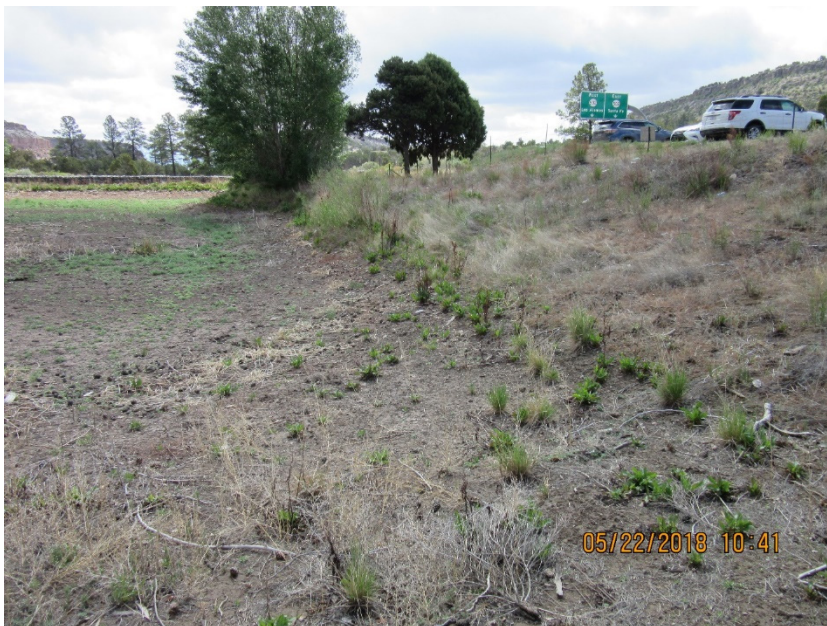
Photo B-4.1-2 May 2018—Upstream southern embankment slope. Slope embankment is stable with established vegetation. Continue to monitor rodent burrows.

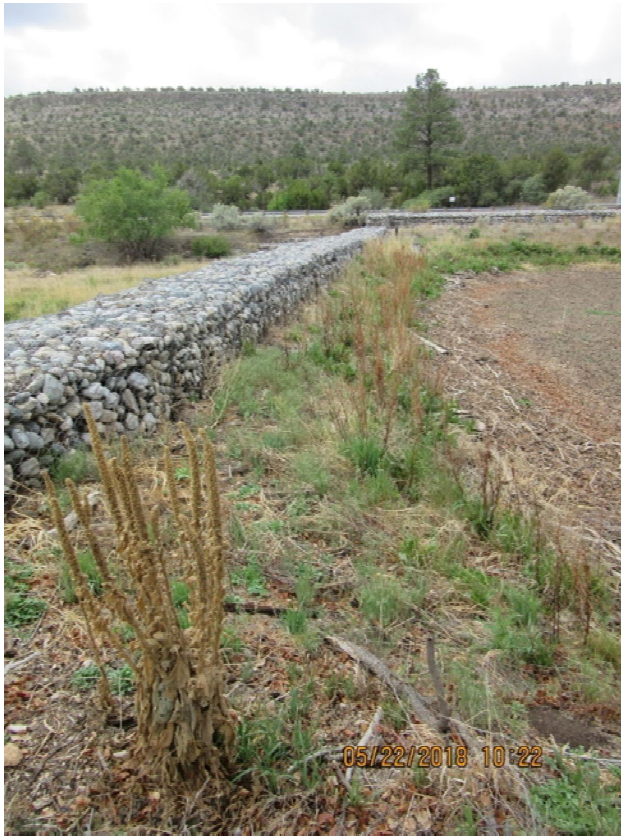
Photo B-4.2-1 May 2018—Abutment looking south. Vegetation well established along weir embankment, continue to monitor sink-holes for change in size/condition. Wet from recent rain event.
